THE BEHAVIOUR OF TRADITIONAL BUILDING SYSTEMS AGAINST EARTHQUAKE AND ITS COMPARISON TO REINFORCED CONCRETE FRAME SYSTEMS; EXPERIENCES OF MARMARA EARTHQUAKE DAMAGE ASSESSMENT STUDIES IN KOCAELİ AND SAKARYA

Demet Gülhan,

İnci Özyörük Güney,

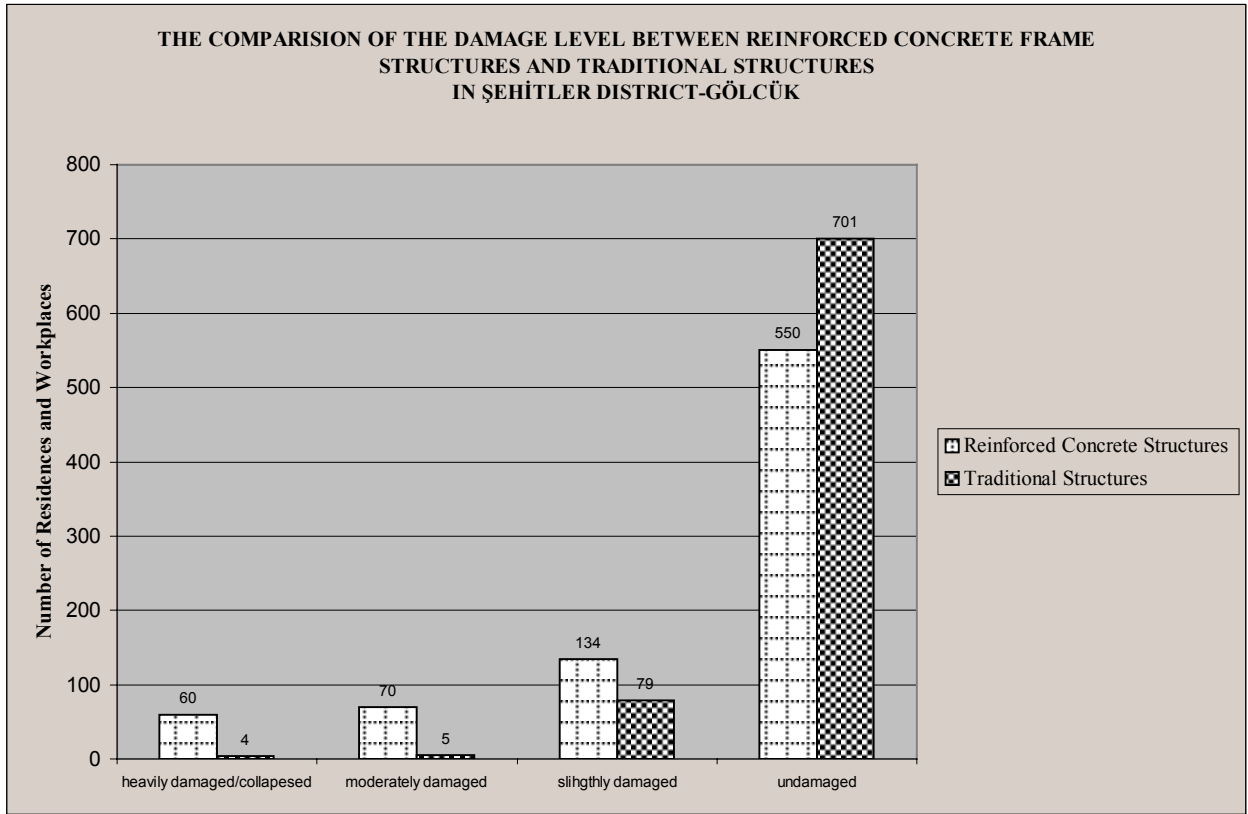
Table 2A.
Reinforced Concrete Structures:814
Traditional Structures:789
Total:1603

The level of damage is less in *Şehitler District*, which is much more a rural settlement area. Most of the buildings are settled towards the side of hills. The soil condition is hard and the building stock is made up of 2-3 storey timber framed structures and 3-4 storey frameless brick and masonry buildings by 49% and, 3-7 storey reinforced concrete framed buildings by 51%. Even though the building stock is almost fifty-fifty in reinforced concrete frame structures and traditional systems (covering timber frame structures, masonry and frameless brick buildings), the level of damage is much higher in reinforced concrete frame structures when compared with the traditional style buildings. (*Table 2a*) Moreover the number of the deaths (available numbers on the site study) was 287 in RC frame buildings whereas it was only 3 in traditional style buildings.

- **Location:** Located near to Rural Area of Gölcük.
- **Damage Assessment:** 1603 Residences and workplaces
- **The ratio of Reinforced Concrete Structures(RC) to Traditional Structures (TS):**
49% TS 51% RC

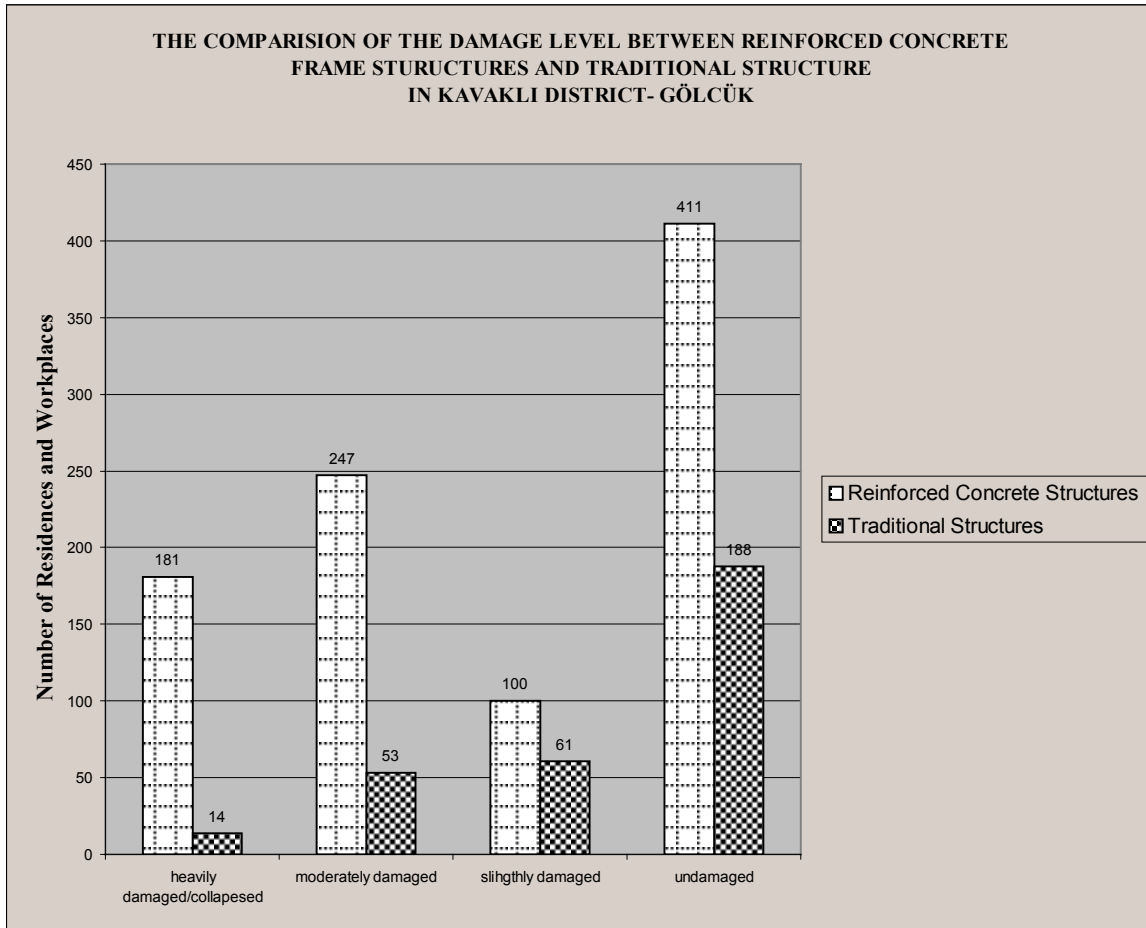
Table 2B.
Reinforced Concrete Structures: 939
Traditional Structures: 316
Total: 1255

In *Kocaeli-Gölcük* the study was carried on three districts; Kavaklı District, Dumlupınar District and Şehitler District. The greatest destruction was seen in *Kavaklı Distirct*, which is located in the city center along the seacoast. Reinforced concrete framed buildings are dominant (75%) and ground bearing capacity is low (poor soil condition) in this area.

- **Location:** Located in the city centre along the seacoast having poor soil conditions
- **Damage Assessment:** 1255 Residences and workplaces
- **The ratio of Reinforced Concrete Structures(RC) to Traditional Structures (TS):**
75% RC 25% TS

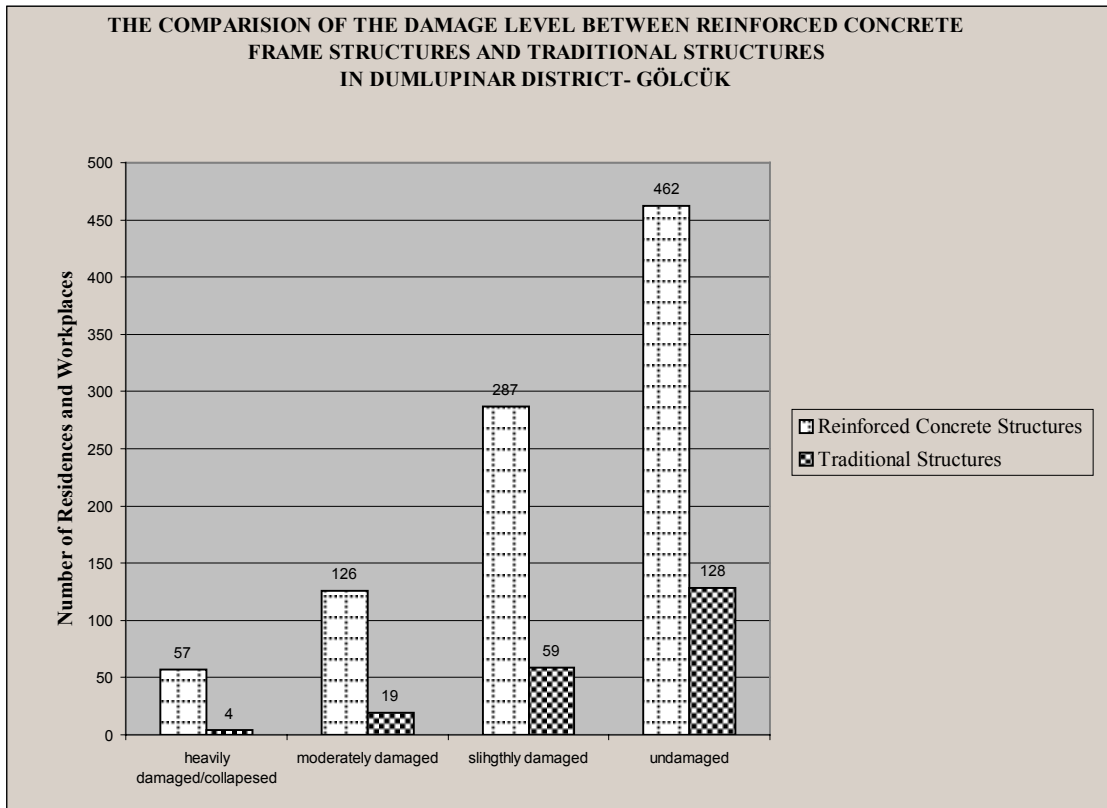
Table 2C.
Reinforced Concrete Structures: 932
Traditional Structures: 210
Total: 1142

- **Location:** Located in the city centre.
- **Damage Assessment:** 1142 Residences and workplaces
- **The ratio of Reinforced Concrete Structures(RC) to Traditional Structures (TS):**
82% RC 18% TS

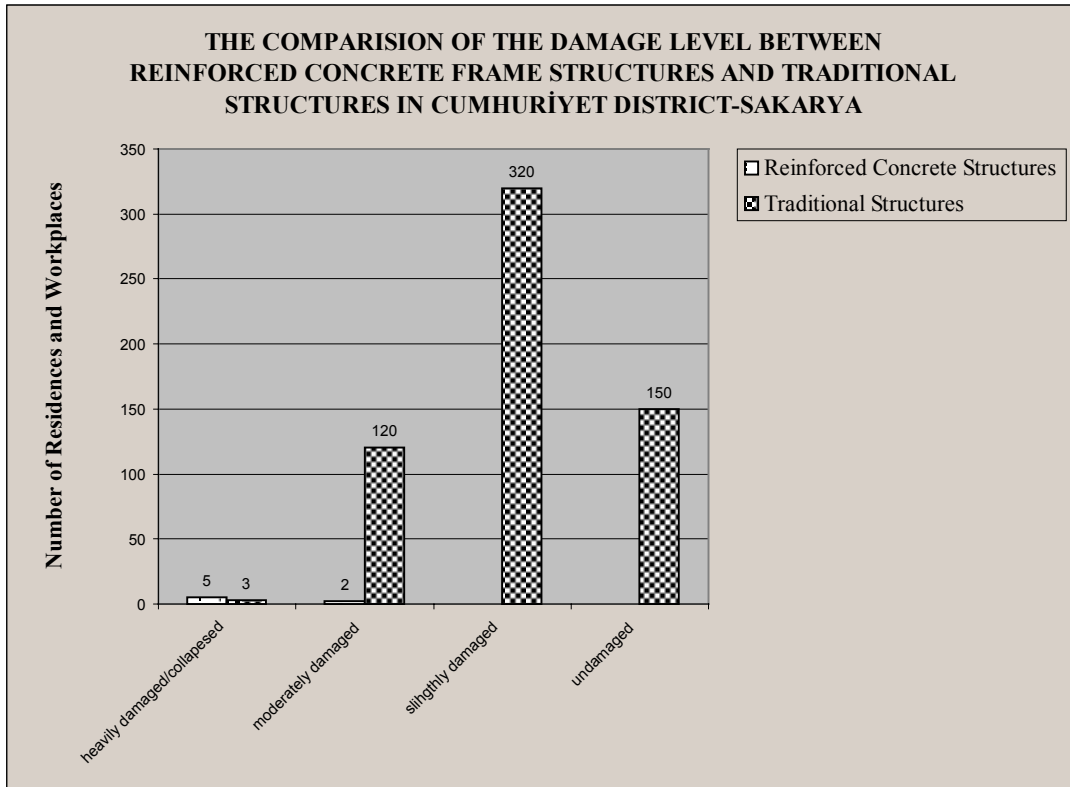
Table 3A.
Reinforced Concrete Structures: 7
Traditional Structures: 553
Total: 600

In **Sakarya** the study was carried on three districts; Cumhuriyet District, Ozanlar District and Yahyalar District. **Cumhuriyet District** is located in the rural area and building stock is mostly made up of **timber framed structure with different infill materials**. These timber framed structures fall into two main groups. The first is called “**humuş**” where the timber frame is infilled with adobe, stone masonry or brick. The other is “**bağdadi**” where the voids between the timber framing elements is filled lighter materials, or with a form of plaster/lime rendering on wooden lath. (**Figure 2**) (Ergünay & Gülkan, 1999) Both kinds of timber framed structures are endowed with good earthquake resistance in spite of the fact that they are slightly damaged, moderately damaged and rarely highly damaged. The number of reinforced concrete frame structures were only 7, 2 of which were under construction and 5 of which were highly damaged. (**Table 3a**)

The damages determined in timber frame structures can be classified as: **slightly damaged**; where vertical cracks were mostly placed either at the corners or at the mid of the walls (0.5mm.), **moderately damaged**; vertical and horizontal cracks on the walls (2mm.), corner cracking especially at openings, wall deformation, deformation of walls along the wooden beams and separation of walls from the beams, roof separation from wall, **highly damaged**; partial collapse in the structural system or total collapse.

- **Location:** Located in the Rural Area of Sakarya. There were only (7) Reinforced Concrete Structure Buildings (2 of them under Construction) and (3) of them were highly damaged
- **Damage Assessment:** 600 Residences and workplaces
- **The ratio of Reinforced Concrete Structures(RC) to Traditional Structures (TS):**
92.5% TS 7.5% RC

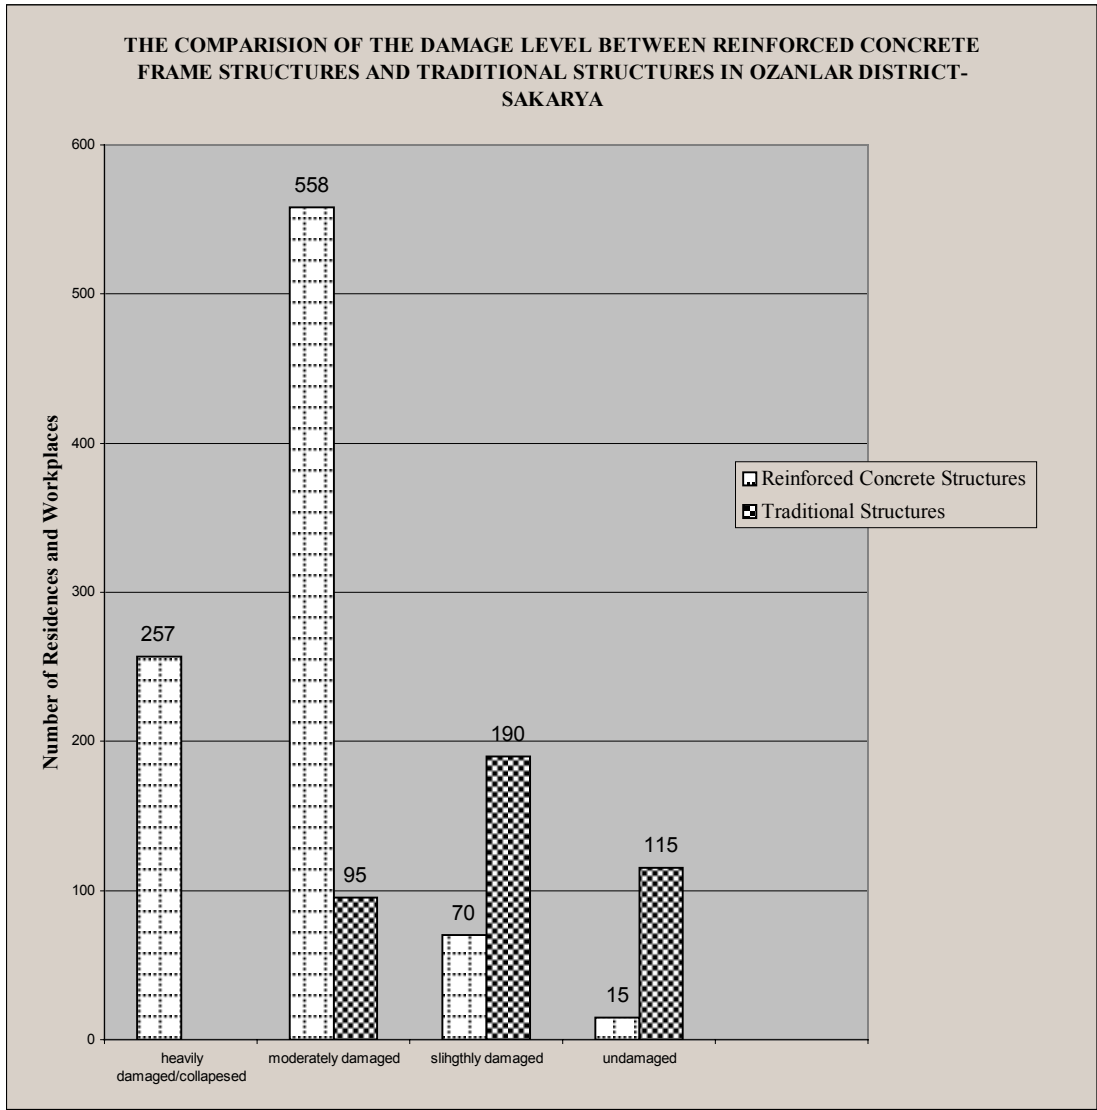
Table 3B.
Reinforced Concrete Structures:900
Traditional Structures:400
Total:1300

Ozanlar and Yahyalar Districts are located in the city centre, mostly made up of co-operatively produced mass-housing buildings. These buildings have very poor construction quality. Therefore the impact of the disaster is very high. The existing traditional building stock was slightly damaged, moderately damaged, undamaged and rarely highly damaged. (**Table 3b, 3c**)

- **Location:** Located in the city centre having mostly co-operative mass housing and some traditional buildings
- **Damage Assessment:** 1300 Residences and workplaces
- **The ratio of Reinforced Concrete Structures(RC) to Traditional Structures (TS):**
70% RC 30% TS

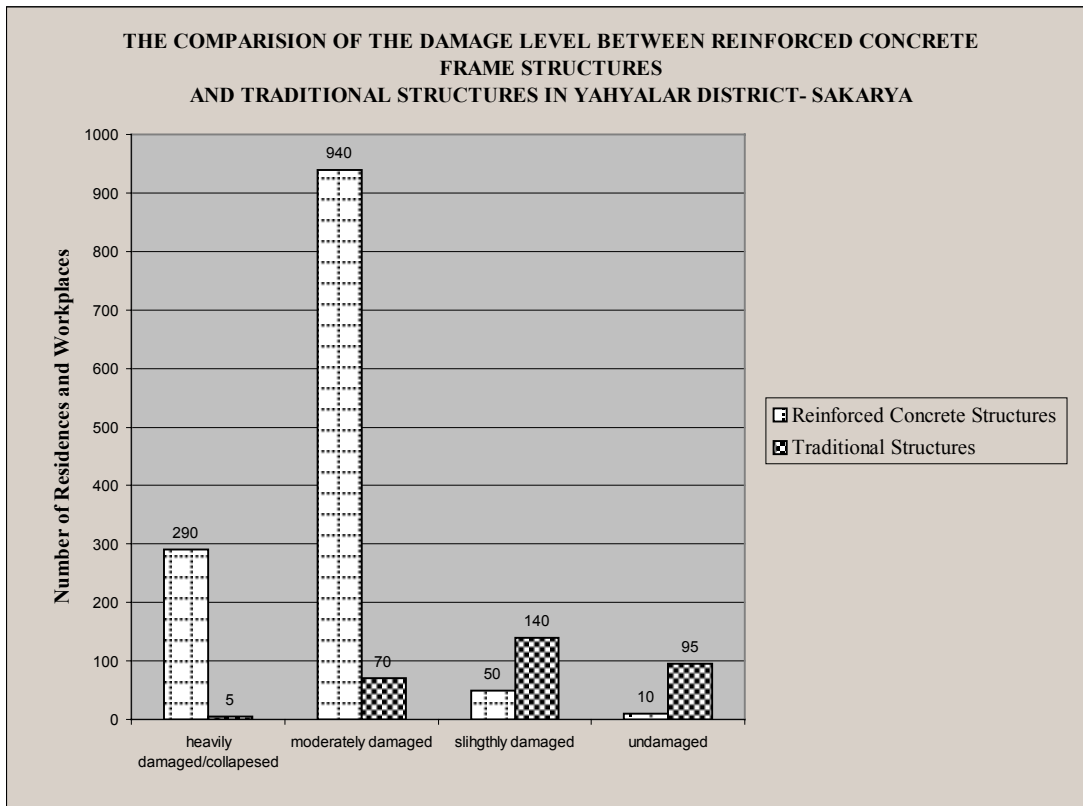
Table 3C.
Reinforced Concrete Structures: 1290
Traditional Structures: 310
Total: 1600

- **Location:** Located in the city centre having mostly co-operative mass housing and some traditional buildings
- **Damage Assessment:** 1600 Residences and workplaces
- **The ratio of Reinforced Concrete Structures(RC) to Traditional Structures (TS):**
80% RC 20% TS
