# Seismic behaviour of the historical structural system of the island of Lefkada, Greece

E. Vintzileou \*, A. Zagkotsis, C. Repapis, Ch. Zeris

*Laboratory of Reinforced Concrete, Faculty of Civil Engineering, National Technical University of Athens, 5, Iroon Polytechniou St., 15773 Zografou, Greece*

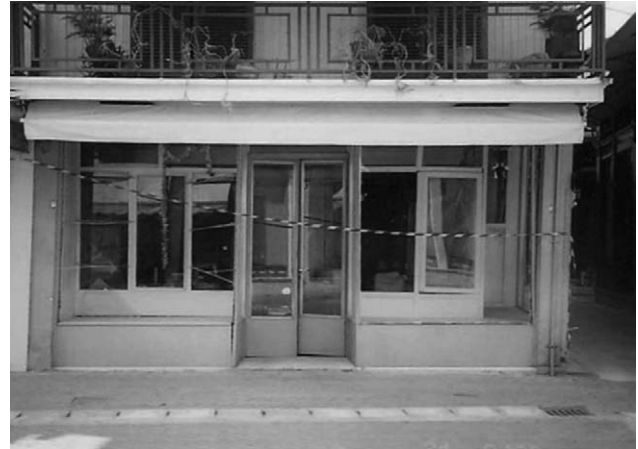
*Excessive lateral displacements:* This is a failure observed in a limited number of buildings (Fig. 11) in which the stone masonry was partly demolished in the ground floor, before the event, when the use of those buildings was modified from residential to commercial. The demolition of masonry was done without previous design. Thus, the secondary bearing system of the ground floor became primary. Since, however, its stiff-

Fig. 11. Permanent interstorey drift in the ground floor.

ness was very limited, this system could not prevent large (permanent) horizontal displacements that led to distortion of the building as a whole at the ground storey.

- (b) Excessive horizontal displacement of the building as a whole: This was a damage observed in buildings in which the stone masonry of the ground floor was partially demolished (without previous design) to accommodate shops in the ground floor (Fig. 11). The analyses proved (Fig. 19) that expectedly-interstorey drifts are large in the most flexible floor, thus, leading to excessive horizontal displacements and to distortion of the building as a whole.

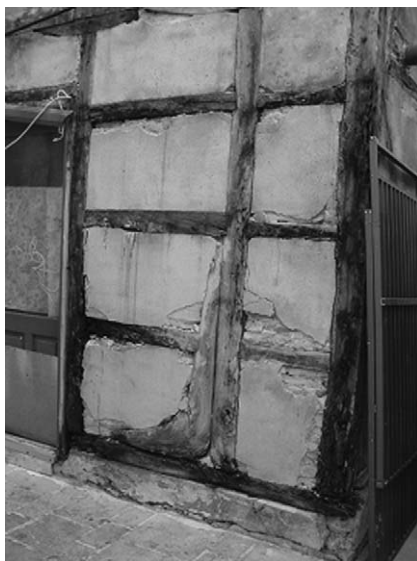
It should be noted that modeling of the perimeter walls in the upper storey(s) did not include some aspects that are of major importance for the behaviour of this type of construction. Thus, the confinement of the filler brick masonry thanks to the surrounding timber elements, as well as secondary mechanisms of energy absorption (such as friction due to slip along timber–masonry interfaces) were not taken into account. In fact, overall energy absorption within the building was only considered in the average sense assuming a (conservative) amount of 5% critical damping. A detailed modeling of timber framed walls was beyond the capabilities of the software and it was out of the scope of the present work. The analysis that was carried out proved that timber the framed walls exhibit high in-plane stiffness. Thus, interstorey drifts are limited, preventing extensive damage. In addition, the limited dimensions of brick panels infilling the timber frame, as well as the adequate bearing capacity of the overdesigned timber elements and their efficient connections, led to very satisfactory out-of-plane behaviour of the approximately 12 cm thick timber framed walls. This is corroborated by the fact that very limited damages were observed in the upper storeys of the buildings (Fig. 16).

Fig. 16. Typical damage of timber framed wall.

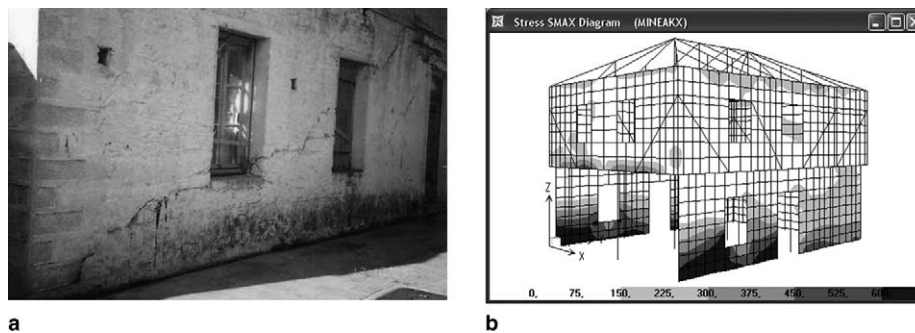
- (a) Oblique cracks in stone masonry in the ground floor: In some cases, in buildings with masonry demolished along one of the sides of the building, oblique cracks along the whole length of the adjacent side were observed. Those cracks (Fig. 18(a)) opened along the whole diagonal of the wall, their axis passing through openings as well. The analysis showed (Fig. 18(b)) that those cracks are due to out of plane action of the longitudinal wall. In fact, due to the demolition of the transverse wall, the longitudinal wall behaves like a vertical slab fixed only along two sides (i.e., at the foundation level and to the existing transverse wall).

Fig. 18. (a) Typical damage of stone masonry, in case of demolished masonry along one transverse façade. (b) Distribution of principal tensile stresses (in kPa), calculated for a similar case. Seismic action perpendicular to the wall under consideration.

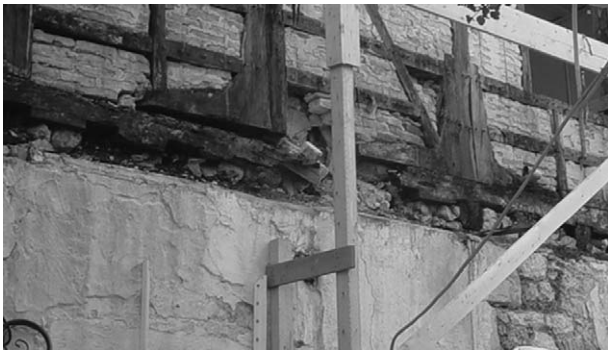
*Timber elements in the top of ground floor masonry:* In several cases, extensive decay of the timber elements was observed due to biological attack (favoured by high percentage of humidity). The form of this damage though obviously not attributed to the earthquake is mentioned herein, since it has affected the seismic behaviour of the buildings. In fact, the reduction, which was observed in some cases, of the sectional dimensions of the timber beam serving as support to the upper storey(s) perimeter masonry walls led to the transfer of loads directly to the secondary timber system of the ground floor.

Fig. 20. Advanced decay of timber elements along the perimeter of stone masonry.

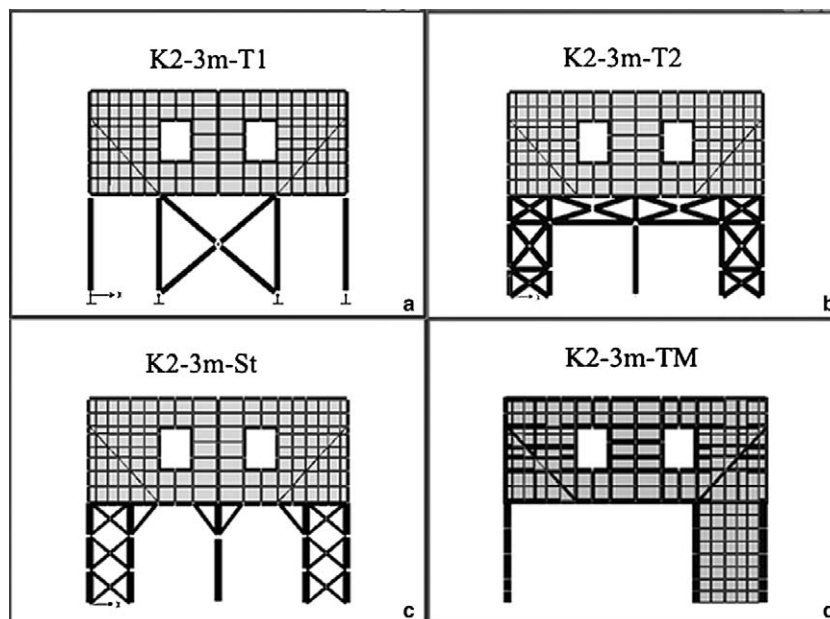
Fig. 21. Intervention schemes analytically investigated.

As shown in Table 1 and in Fig. 21, two alternative timber frame schemes were considered (Fig. 21(a) and (b)), a steel frame (Fig. 21(c)), as well as partial demolition of masonry along one façade (Fig. 21(d)). The criteria applied to evaluate the efficiency of the building under the examined intervention schemes were (a) their first mode period and (b) their lateral displacements, compared to those of the undamaged reference building with masonry along the entire perimeter of the ground floor. As shown in Table 4, all proposed schemes are correct in principle and they serve the purpose for which they were conceived, since both period and displacements are substantially reduced. It should be noted, however, that the results of this investigation are indic-
