# Seismic behaviour of the historical structural system of the island of Lefkada, Greece

E. Vintzileou \*, A. Zagkotsis, C. Repapis, Ch. Zeris

*Laboratory of Reinforced Concrete, Faculty of Civil Engineering, National Technical University of Athens, 5, Iroon Polytechniou St., 15773 Zografou, Greece*

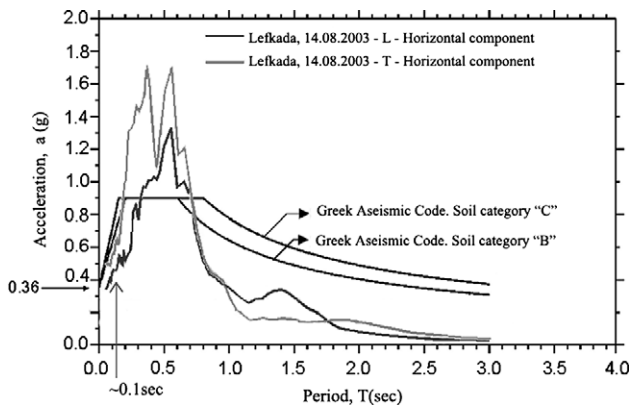
Seismic actions were calculated according to [4]. Assuming a behaviour factor,  $q$ , equal to 1.50, corresponding to a low ductility system, a maximum design spectral acceleration equal to  $0.60(g)$  is estimated, corresponding to a peak ground acceleration for the city of Lefkada, equal to  $0.36(g)$ . On the basis of the elastic response spectrum of the above earthquake record (Fig. 13), the actually demanded spectral acceleration, corresponding to a first mode period of vibration of approximately 0.1 s, is about  $0.5(g)$ , which is well below the above design value, specified in [4]. Although the

Fig. 13. Linear elastic response spectrum of the August 14th, 2003 earthquake [1].

structures were not designed in the modern sense of the term, and considering the spectral demands for these buildings under the subject earthquake, one may observe, on the basis of the registered damages, that the available margins of safety of this historical system are quite large.

The typical reference building (K2-4) proves to be very stiff, with the first mode period about 0.1 s. The period increases substantially when stone masonry is provided only in some of the four sides of the building (Table 3). Based on the elastic response spectrum of the 2003 earthquake (Fig. 13), this increase in the natural period leads to higher accelerations imposed to the building. In case of the masonry being demolished completely in the ground floor, the natural period is several times higher than that of the reference building. The calculated values of the natural periods indicate that the stone masonry of the ground floor is-expectedly the major stiffening factor for the buildings. Furthermore, it is obvious that the secondary bearing system of the ground floor (i.e., the system of the timber columns) does not contribute to the seismic response of the buildings. This seems to confirm the hypothesis put forward by Touliaatos and Gante [2] that the secondary bearing system plays a considerable role in case stone masonry of the ground floor is heavily damaged or even partially collapsed due to the earthquake. In fact (see also Section 4.6), this secondary system is able to transfer safely the vertical loads of the entire building superstructure until the masonry is repaired to be ready to resist the next earthquake. This hypothesis seems to be confirmed also by the fact that the constructors provide a well detailed connection between the perimeter wall collector beams at the base of the upper storey(s) and the secondary bearing system (Fig. 8), even though this is not needed when the perimeter stone masonry walls are present in the ground floor.

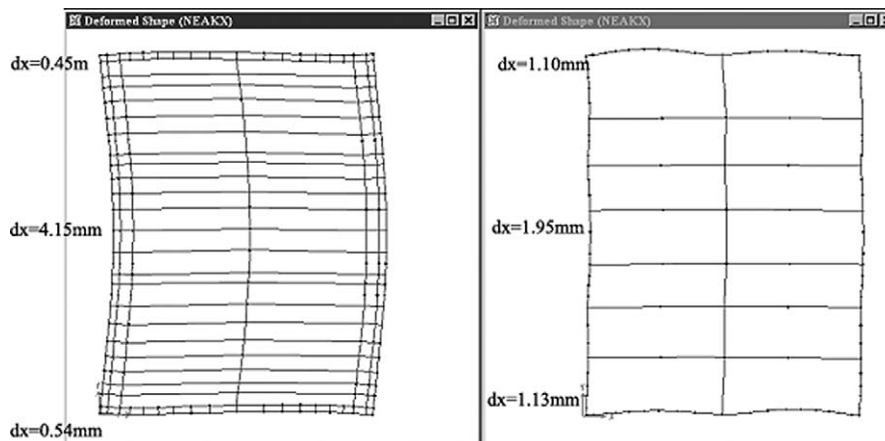
The beneficial effect of the timber roofing is quite apparent in the case of intermediate floors as well. In fact, as shown in Figs. 14 and 15, the bearing system

Fig. 14. Building (K2-4): Horizontal (in-plane) deformations of intermediate floor and roof without contribution of timber pavement for seismic action along the short dimension of the building.

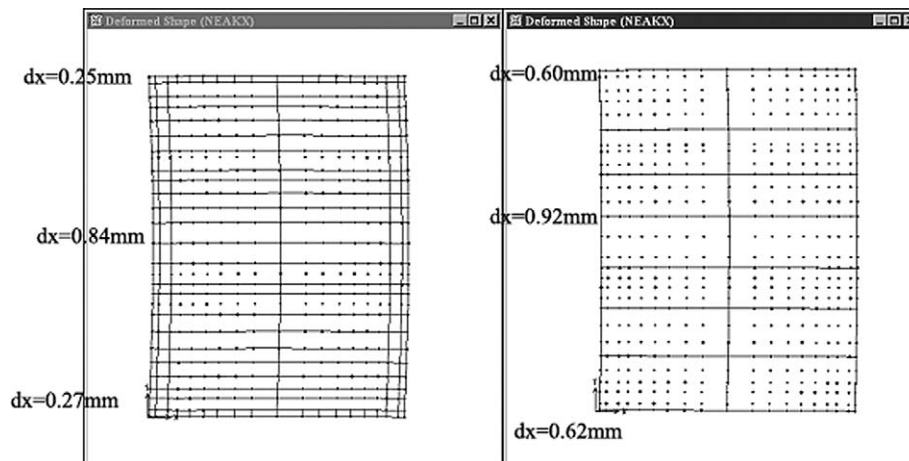
Fig. 15. Building (K2-4): Horizontal (in-plane) deformations of intermediate floor and roof in presence of timber pavement for seismic action along the short dimension of the building.

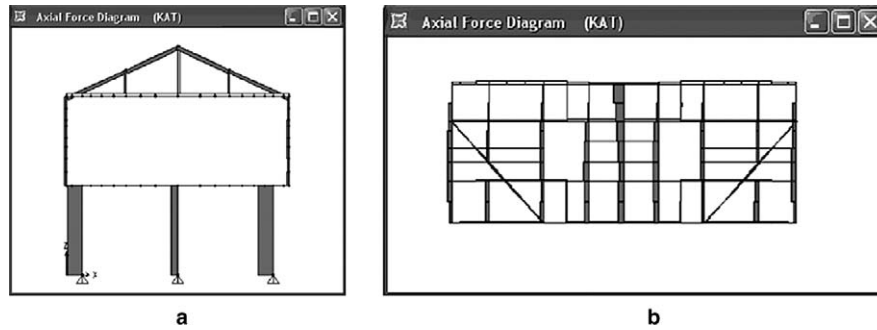
Fig. 17. Axial forces in timber elements under vertical loads. (a) Columns in ground floor for fully demolished stone masonry: maximum calculated axial force = 55 kN, minimum resistance = 500 kN. (b) Timber framed walls: maximum calculated axial force = 11 kN, minimum resistance = 225 kN.

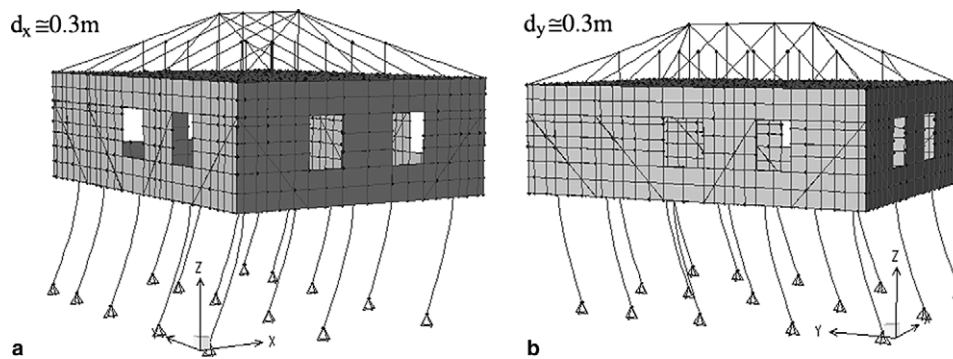
- (b) Excessive horizontal displacement of the building as a whole: This was a damage observed in buildings in which the stone masonry of the ground floor was partially demolished (without previous design) to accommodate shops in the ground floor (Fig. 11). The analyses proved (Fig. 19) that expectedly-interstorey drifts are large in the most flexible floor, thus, leading to excessive horizontal displacements and to distortion of the building as a whole.

Fig. 19. Deformed shape of building, for fully removed ground floor masonry: (a) seismic action along the transverse axis of the building; (b) seismic action along the longitudinal axis.
